GFRP STRENGTHENING OF RC CONTINUOUS BEAMS

A THESIS SUBMITTED IN PARTIAL FULFILMENT
OF THE REQUIREMENTS FOR THE B.TECH
AND M.TECH DUAL DEGREE

IN
CIVIL ENGINEERING
(STRUCTURAL ENGINEERING)

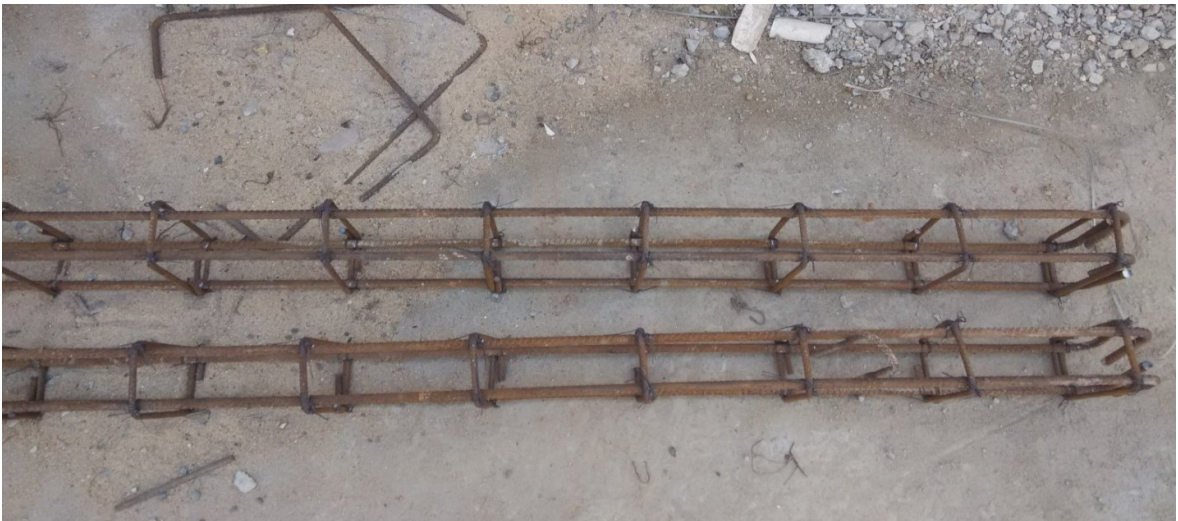
All the beams had same longitudinal and transverse steel reinforcement ratios and were casted and tested to failure. The beams were reinforced with two 12 mm diameter at the bottom, two 10 mm diameter bars as top reinforcement throughout the length to strengthen the beam in flexure. Stirrups of 8 mm diameter high-yield Strength Deformed (HYSD) bars were provided throughout the beam at 150 mm center-to-center distance to make the beam weak in shear. And, finally 6 mm bars are used as hanger bars for lifting of the beam.

Fig 3.1 Steel Reinforcement for the beam

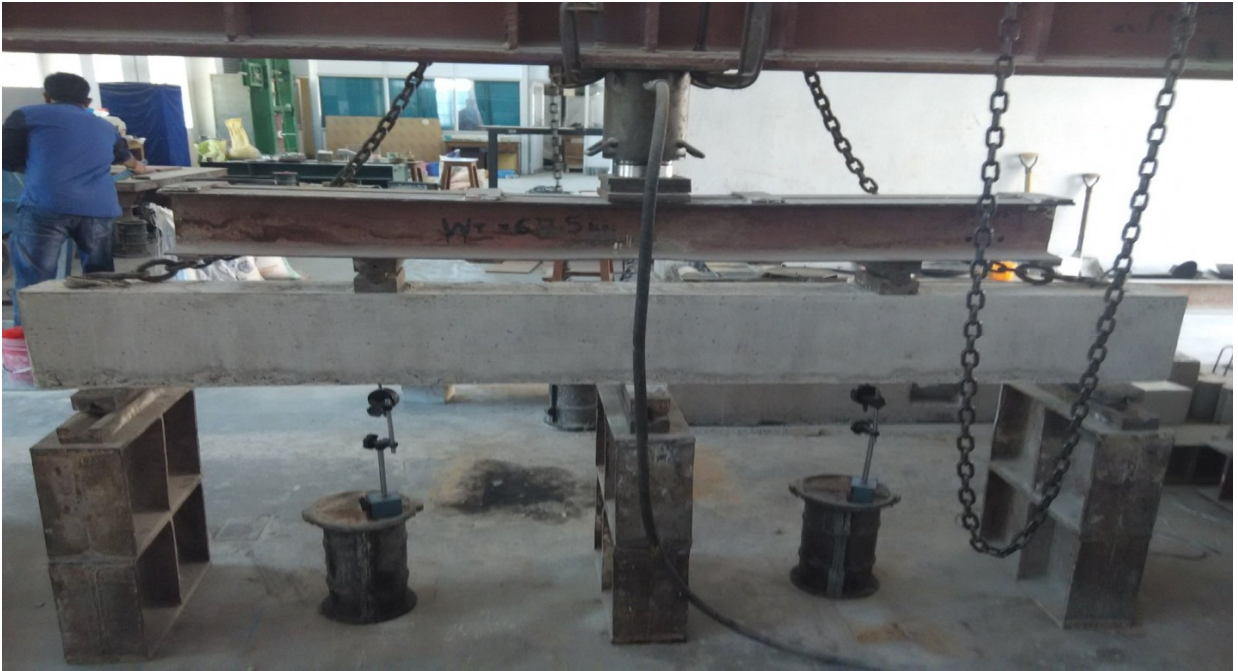
Fig 3.3 Test Setup for Control beam

The control beam, CB1, failed in the RC shear failure mode. The wide diagonal shear cracks were observed. The cracks were well extended from mid support to the left centre span. The first crack of CB1 was obtained at 80KN load and the ultimate failure of the beam occurred at 240KN load.

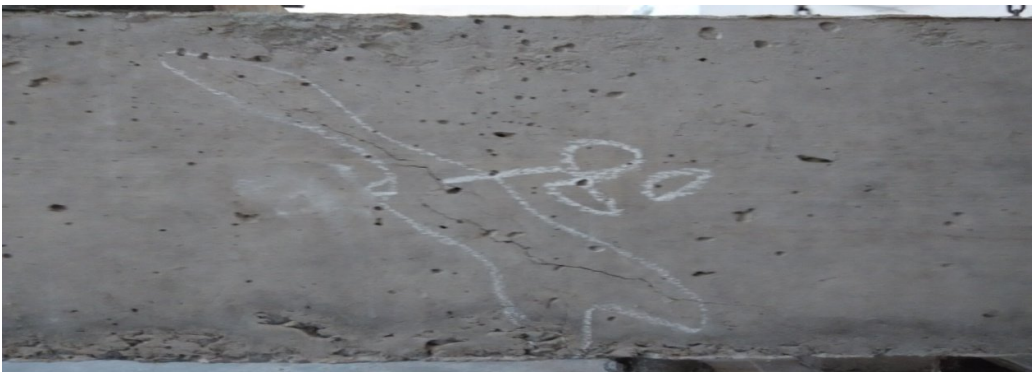
Fig 3.4 First Crack on the beam

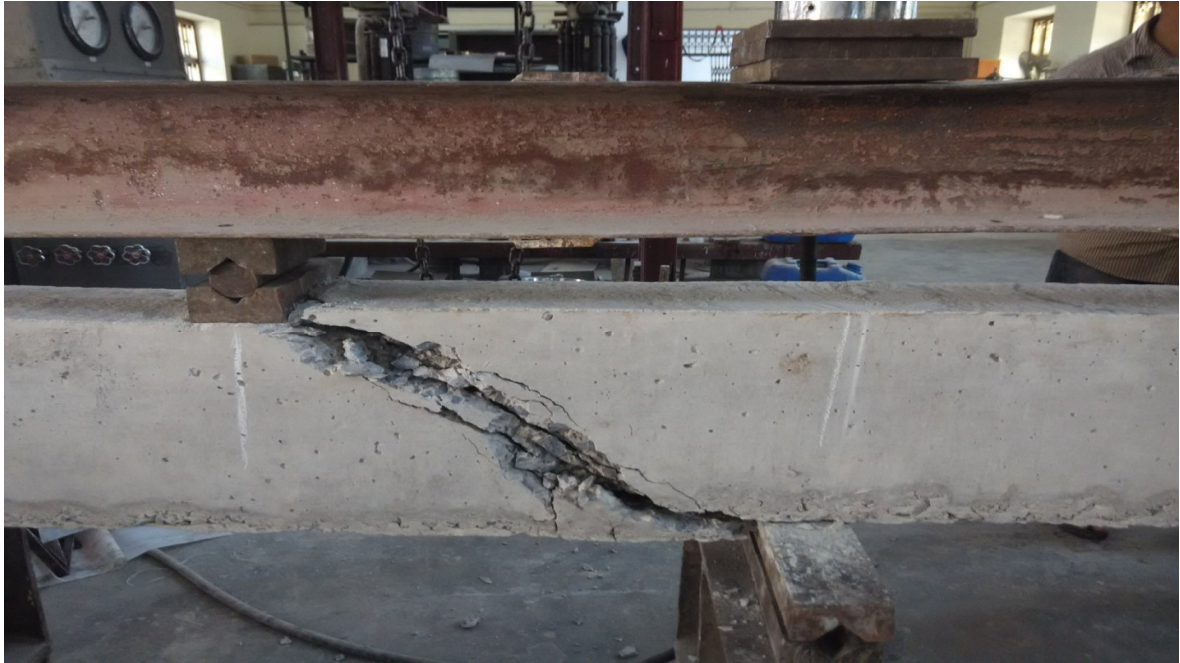
Fig 3.5 Ultimate failure of the beam

The control beam failed completely in shear. The failure started first at the center span areas and then propagated towards the central support and finally failed in shear.

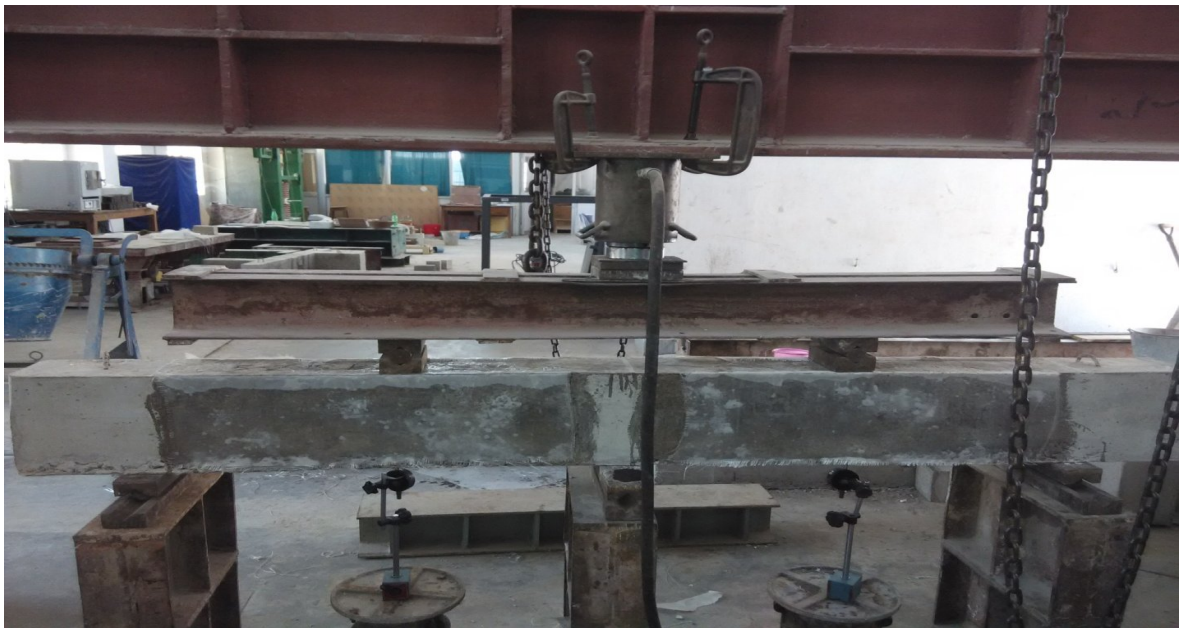
Fig 3.6 Test setup for strengthened beam 1

Single layer of glass FRP was applied at the surfaces as shown in the above figure to prevent shear failure. And it was observed that the beam failed due to debonding of FRP sheet, and flexural as well as diagonal cracks were also observed. Ultimate load was found to be 288 KN.

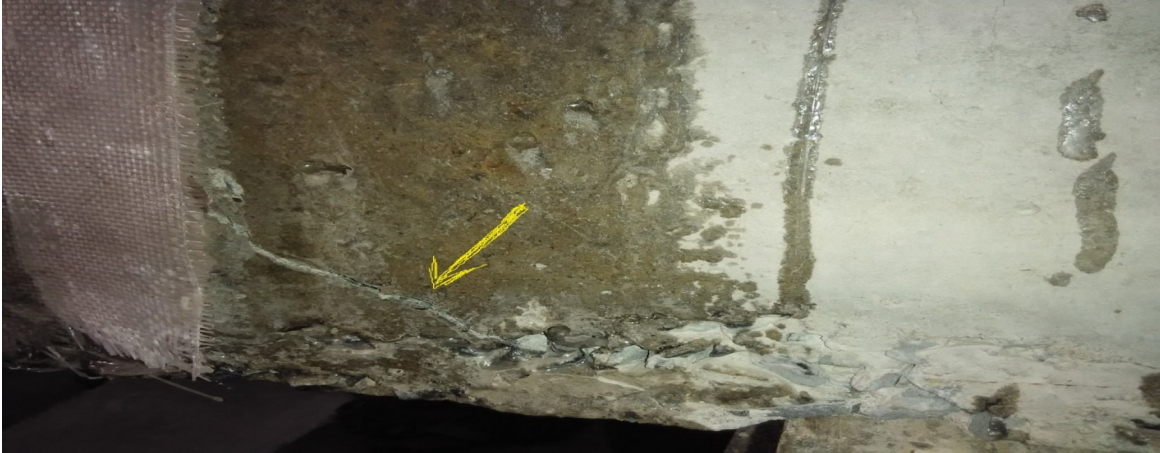
Fig 3.7 Failure pattern of SB1

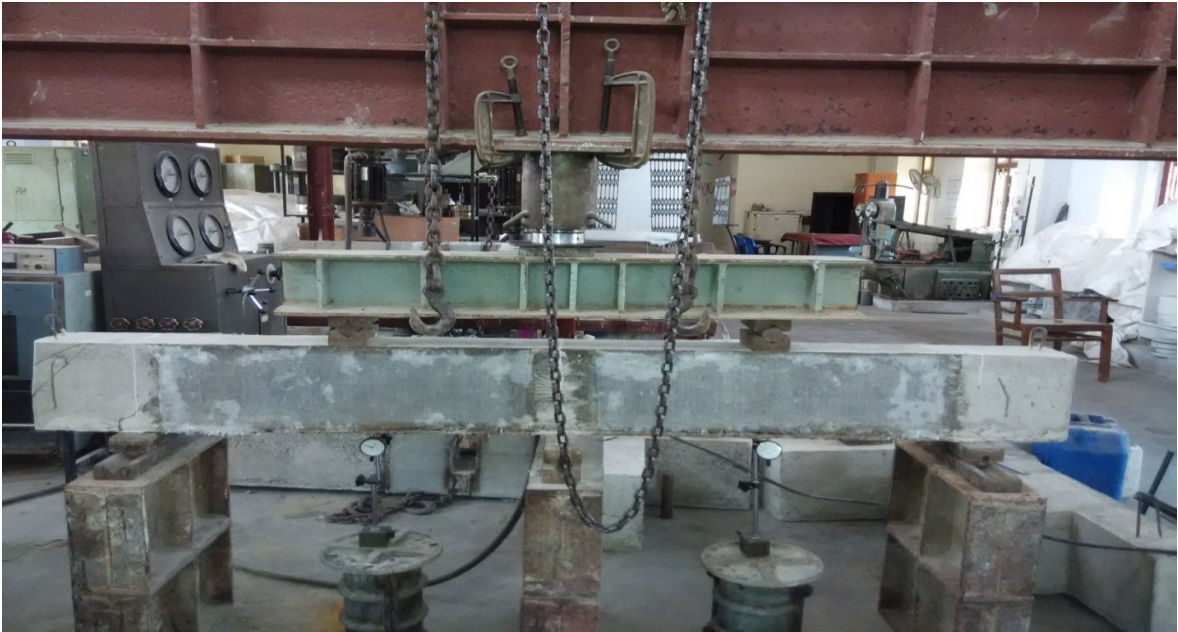
Fig 3.8 Test setup for SB2

Double layer of glass FRP was applied at the same surfaces as shown above in the figure to prevent shear failure. And it was observed that the beam failed due to debonding of FRP sheet. This beam showed higher strength compared to CB1 and SB1 and ultimate load was found to be 310KN.

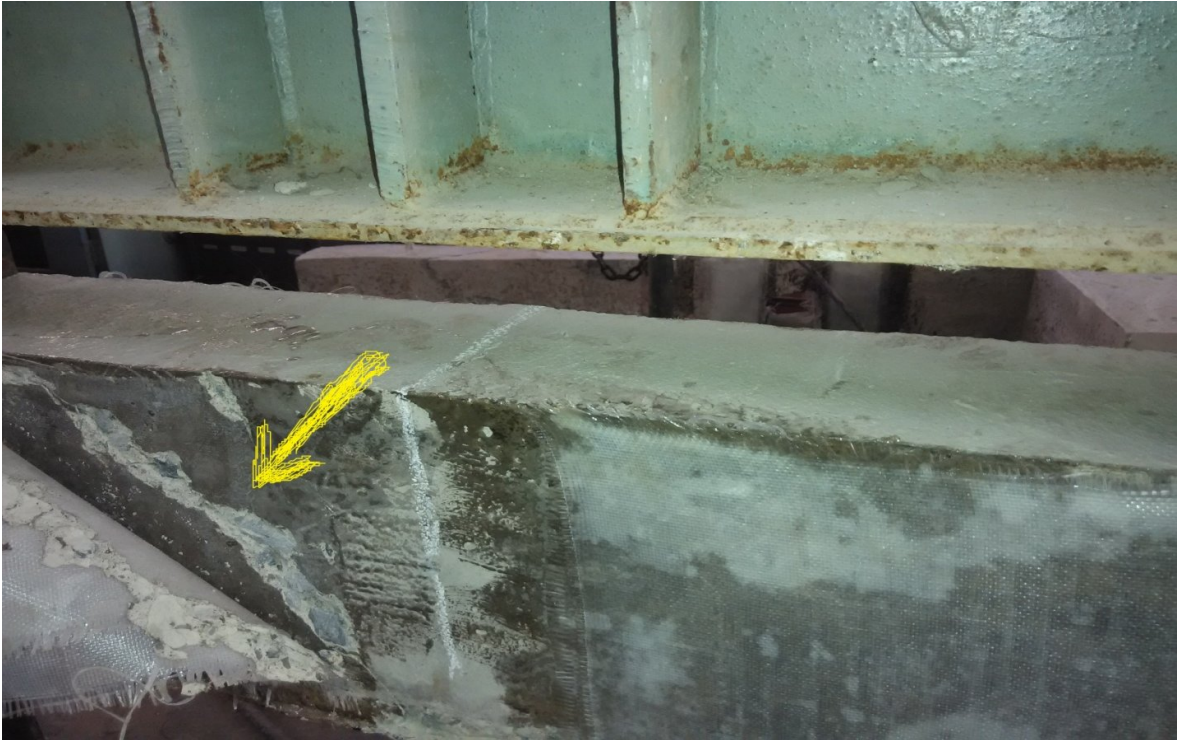
Fig 3.9 Debonding failure of SB2

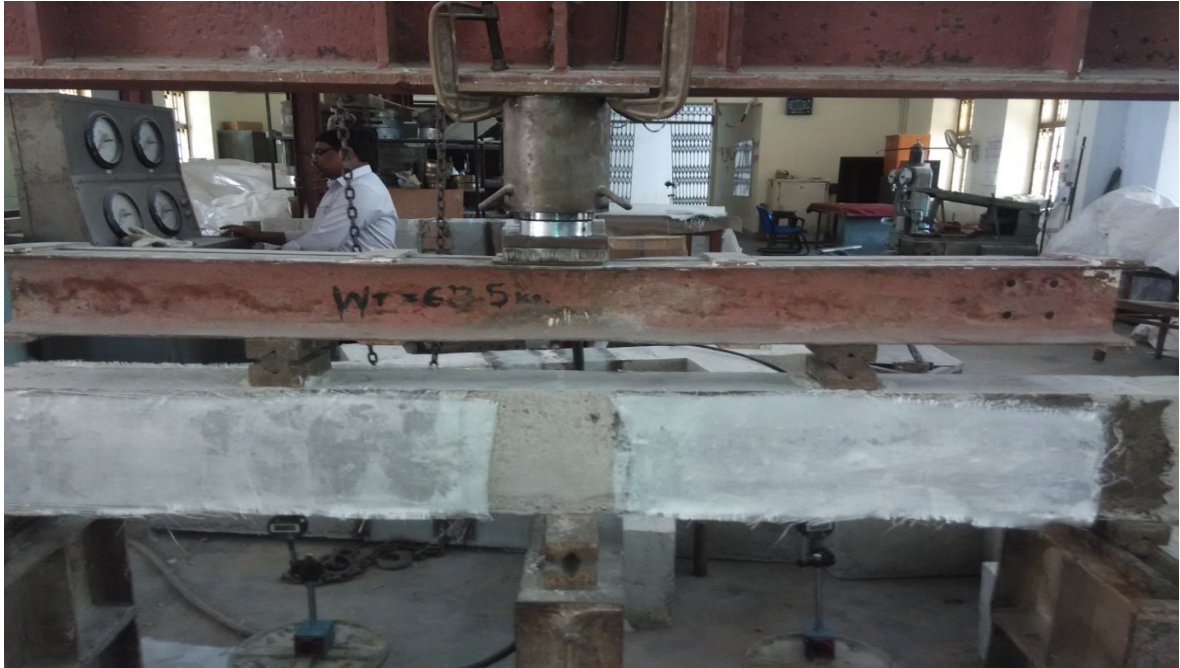
Four layers of FRP were applied on the similar surfaces like in SB1 and SB2 to make it strong in shear. And the result was that this beam also failed due to debonding of FRP sheets and flexural cracks were found at the central support due to negative bending moment (hogging) at the central support. The ultimate load of this beam was 340 KN.

Fig 3.10 Test Setup for SB3

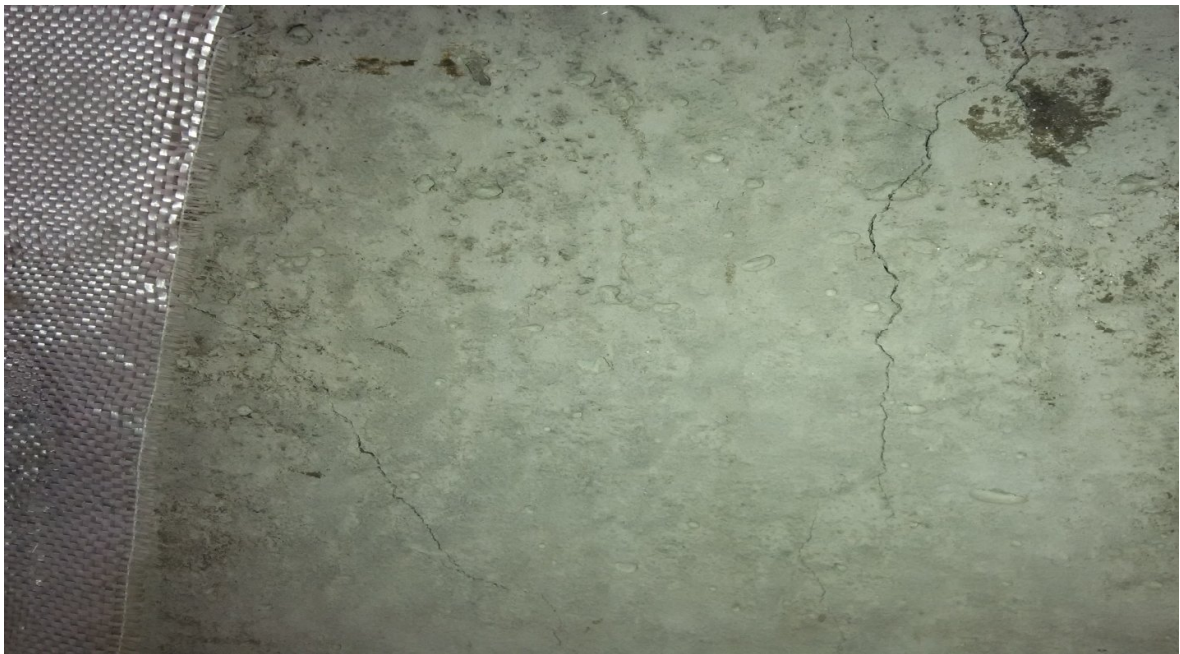
Fig 3.11 Debonding failure of SB3 accompanied by cracks

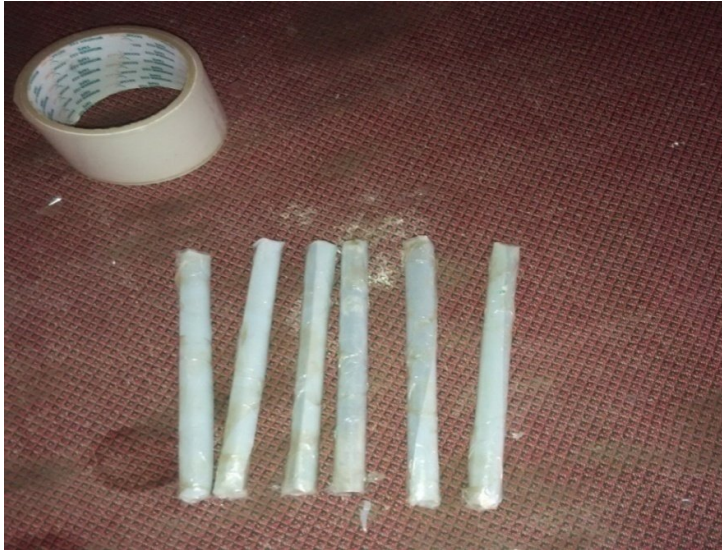
The holes in the beam were made while casting of the beam by using mild steel bars rolled in plastic sheets as shown in figure

Fig 3.12 Rolling the mild steel bar with plastic sheet

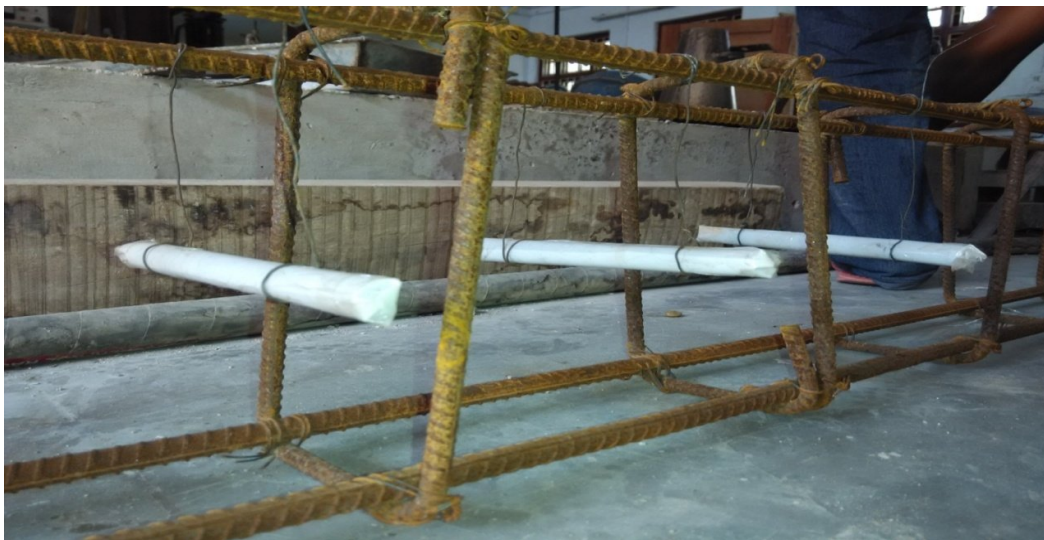
Fig 3.13 Tying of the bars with steel reinforcements

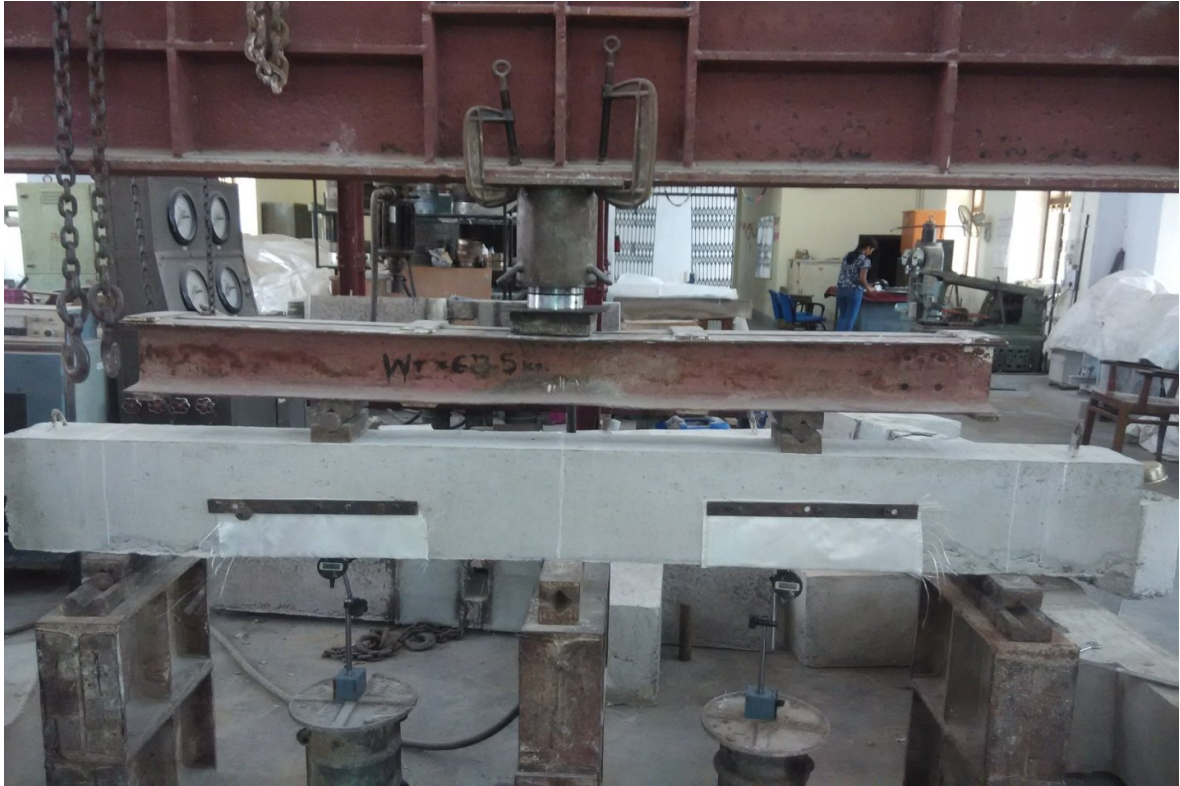
In SB4 beam, steel bolt system with unbonded FRP sheet was used to avoid debonding of FRP.

Fig 3.14 Test Setup for SB4

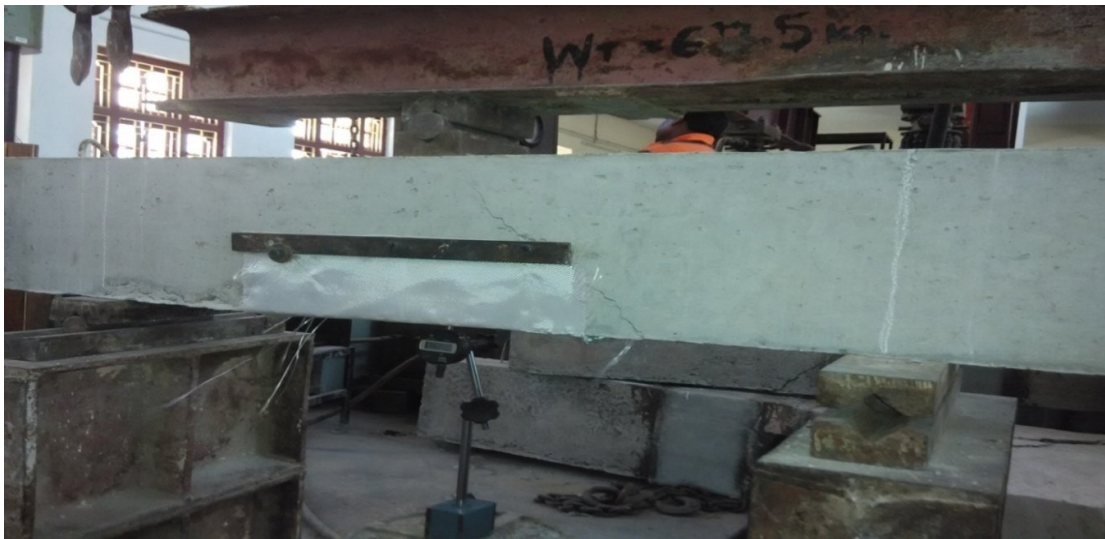
Fig 3.15 Development of first crack at 110KN

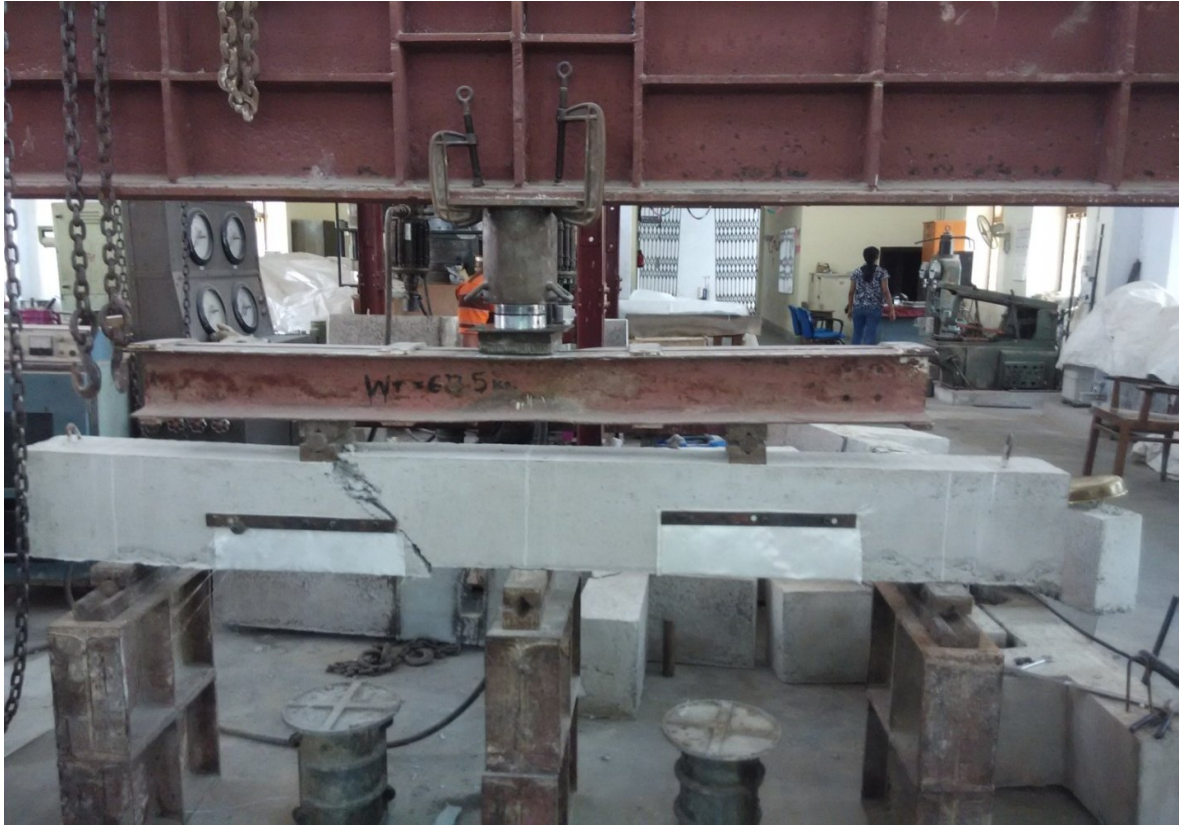
Fig 3.16 Ultimate failure of the beam at 270 KN

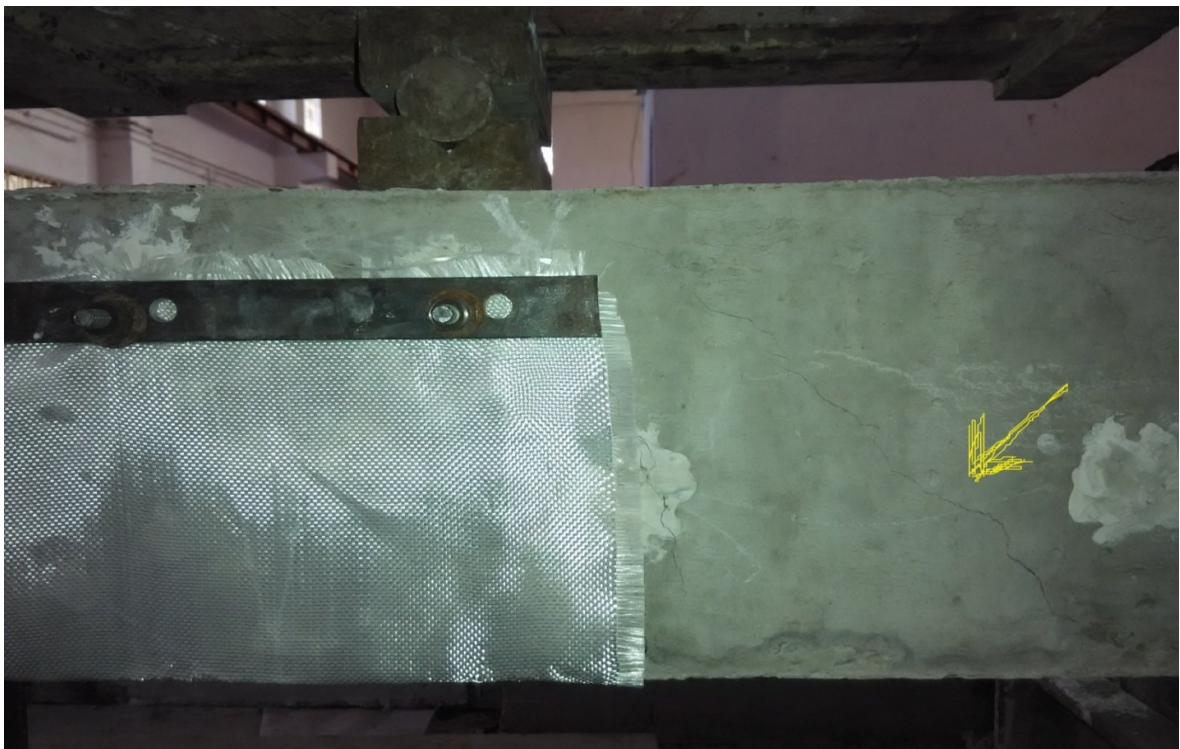
Fig 3.18 Diagonal crack at the extreme right support towards load point

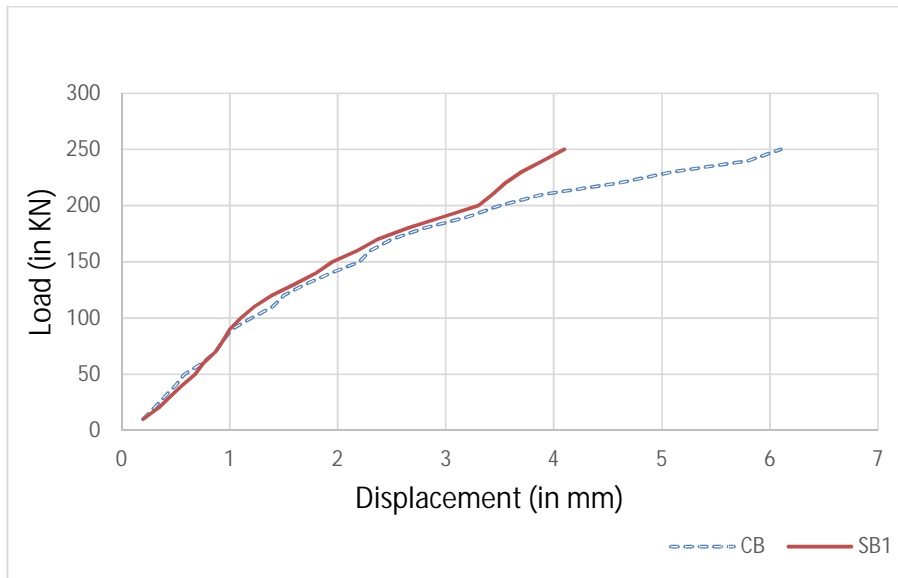
To strengthen SB1, single layer of glass FRP was applied at the surfaces to prevent shear failure. And it was observed that the deflection values were less than that of the control beam for the same load value. At lower load value, debonding of FRP without concrete cover occurred and SB1 finally failed in shear. At the load of 110 KN initial cracks appeared. Later on increasing the load values, the cracks propagated further and the beam failed with an ultimate load of 288 KN.

Fig 4.1 Load-displacement curve for SB 1 vs CB

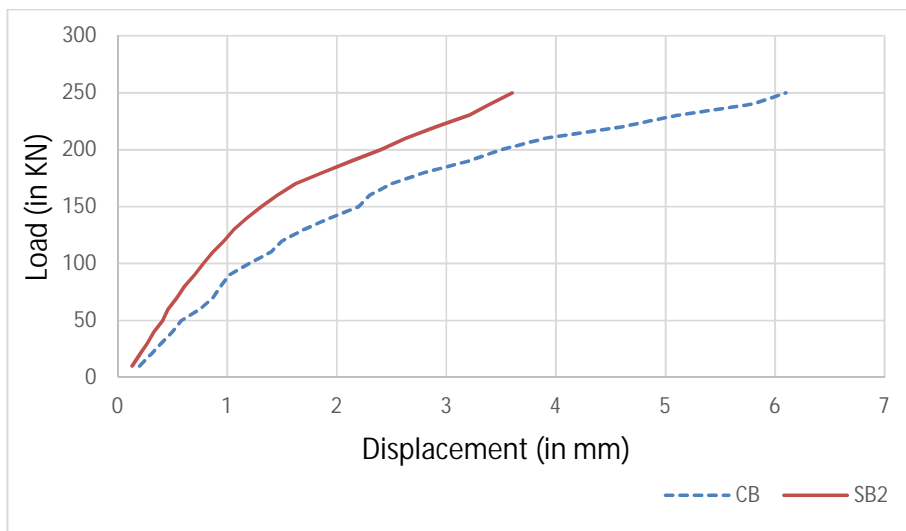
SB2 was strengthened with two layers of glass FRP applied at the surfaces similar to SB1 to prevent shear failure. And from Fig 4.2, it is clear that the deflection values of SB2 are less than that of the control beam for the same load value. At the load of 130 kN initial hairline cracks appeared. Later on increasing the load values, the cracks propagated further and the beam failed with an ultimate load of 310 kN.

Fig 4.2 Load-displacement curve for SB 2 vs CB

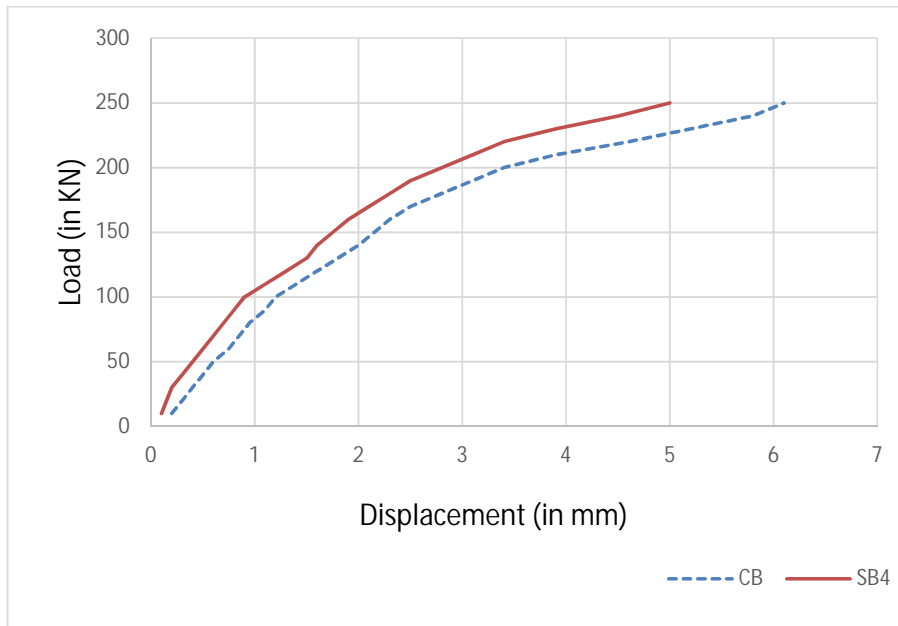
The technique of strengthening the beams with unbonded glass FRP was used. End anchorage was provided using steel bolts and plates. In SB4, one layer of glass FRP was U-wrapped just under the loading points. The ultimate failure of the beam was in shear at 270 KN. And it was observed that the displacement values were nearer to that of the control beam.

Fig 4.4 Load-displacement curve for SB 4 vs CB

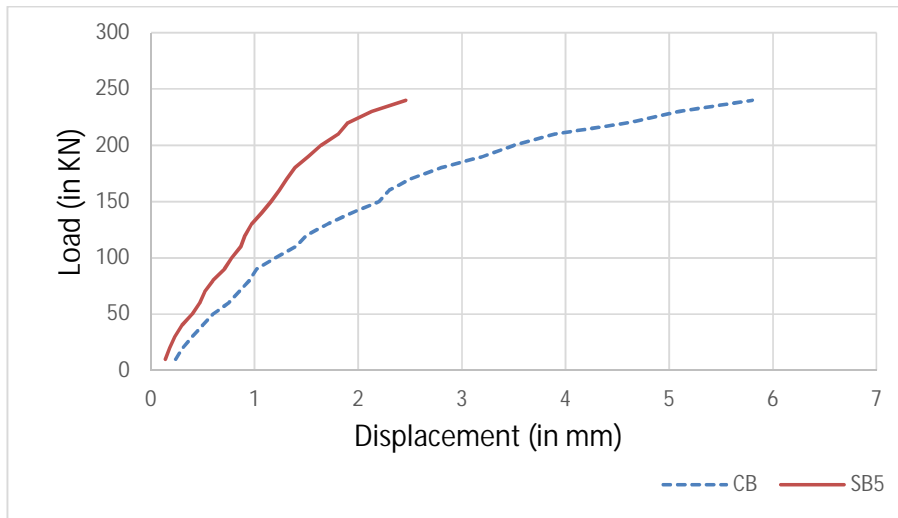
SB5 was also strengthened with unbonded glass FRP provided with end anchorages using steel bolts and plates. In SB5, one layer of glass FRP each was U-wrapped from loading point to central support. And expectedly, the beam showed much resistance to shear failure. Interestingly, the beam developed cracks due to shear from the right mid-span to the end support and also cracks were found at the central support. The ultimate failure occurred at 318 KN.

Fig 4.5 Load-displacement curve for SB 5 vs CB
